**ENGINEERING GEOLOGY AND GEOTECHNICAL INVESTIGATION
OF HIGHWALL STABILITY
OF THE PROPOSED CYPRESS OPENCAST MINE
MT WILLIAM FAULT ZONE, CYPRESS NORTH BLOCK
UPPER WAIMANGAROA**

A thesis
Submitted in partial fulfilment
Of the requirements for the degree of
Master of Science in Engineering Geology
University of Canterbury
By

June 2004

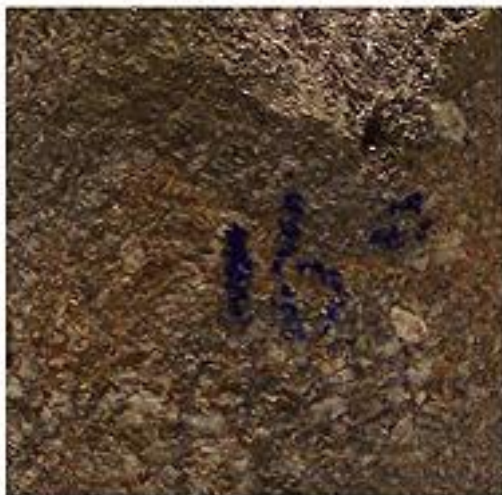
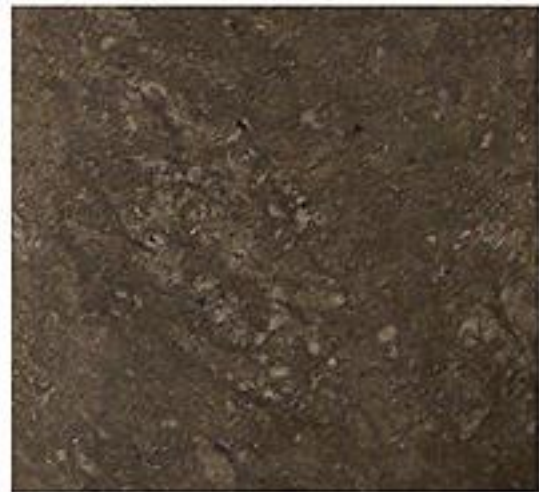
Figure 2.2 Representative Samples* of Unit 2.1 and 2.2

Unit 2.1 Coarse Sandstone

Unit 2.2 Bioturbated med-fine Sandstone

Unit 2.2 represent a fining downwards of the upper unit (2.1), with the same composition dominated by quartz grains. Greater transportation associated with the finer sequence as suggested as the grains tend to be sub-angular. The unit also represents increased bioturbation and carbonaceous banding. The presence of bioturbation indicates less constant reworking and probably marks the transition from a tidal to a shelf environment.

The massive coarse lithologies present in this geotechnical unit are med-coarse grained sandstones (Unit 2.1) which is in a gradational contact with the Kaiata mudstone (Unit 1.2) and as a coarse grained conglomerates resting unconformably on the basal sequence (Unit 2.5). Both these units are coarse sandstones, typically quartz-rich with feldspar, minor pyrite, and sand sized mica grains that mimics the parent rock. Both units show a varying degree of weathering, especially associated with fractures which commonly display extensive iron staining. The quartz grains tend to be the dominant larger grain, and are typically sub angular to angular. Unit 2.1 has minor bioturbation and gradational change into the next unit which has increased bioturbation. Unit 2.5 tends to be lighter in colour, with less frequent inclusions of carbonaceous bands. The depositional environment for these coarser units was most likely a braided stream environment, like the peneplain discussed in Chapter One.

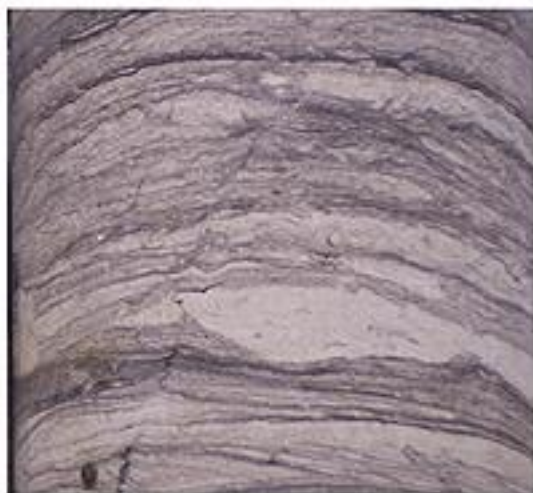
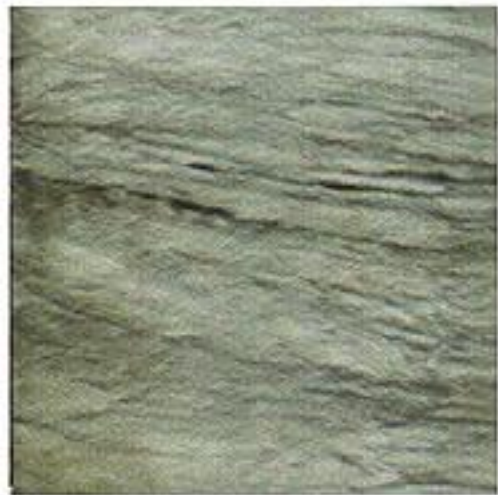
2.3 Representative Samples* of Unit 2.3 and Unit 2.4

The laminated units are separated on the basis of the grain size, with a finely laminated silty mudstone (Unit 2.3) and finely laminated fine sandstone (Unit 2.4) being recognised. The laminations in the units are pronounced alternating dark/light layers with the dark layers representing increased carbonaceous/mica-rich mudstones, while the lighter layers are generally siltstones/fine sandstone. The units are inter-bedded with the coal seams present in the basin, and make up the majority middle sequence seen in the Brunner Coal measures section with predominant thick bands of medium sandstone. These units represent coastal channel distributaries and inter-distributaries at areas such as the mouths of fluvial systems discharging into the sea.

Unit 2.3 Banded Silty Mudstone

2.4 Fine Sandstone

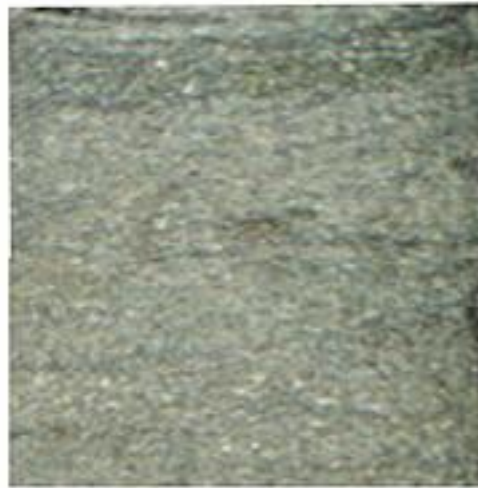
2.4 Representative Sample* of Unit 2.5

Unit 2.5 , Medium - Course Sandstone

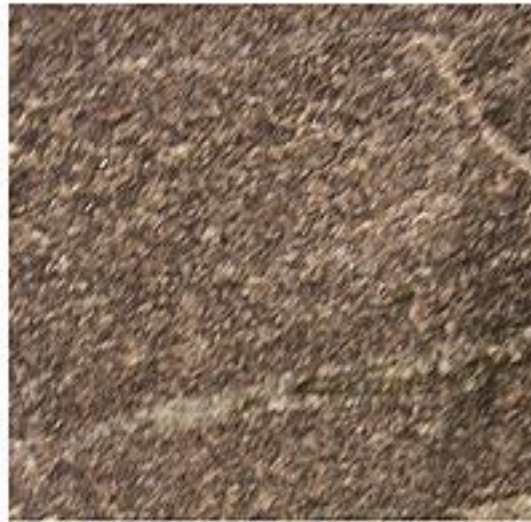
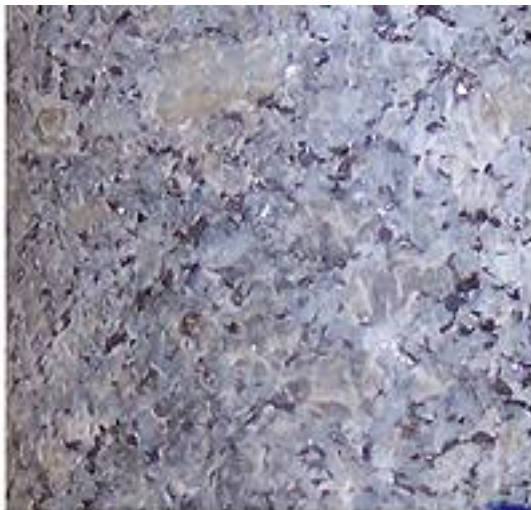
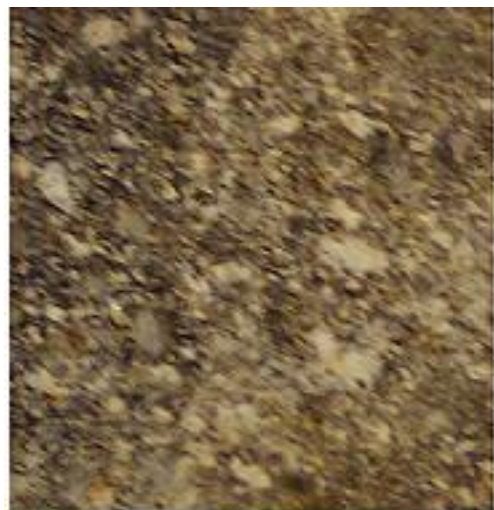
2.5 Representative Samples* of Units 3.1, 3.2 and 3.2b

The Greenland Group consists of greywacke and argillite, which is usually bedded and closely jointed, with a slaty cleavage. The unit is thermally altered to biotite Hornfels near granitic intrusions which extend the length of the MWFZ, and is generally dark grey, fine to medium grained with foliation 30-50° degrees with frequent veins of quartz, porphyry and rare calcite. The Contact with the Berlins Porphyry (Unit 3.2) is usually distinct and sharp along foliation, and is usually associated with increased quartz content near the contact.

The granitic lithology (Unit 3.2) present along the Mt William Range comprises medium-grained biotite granite and granodiorite. The intrusive nature of the pluton lends to interfingering with the hornfel basement unit (unit 3.1). Close fracturing of the basement rocks near the MWFZ lends itself to extreme weathering (Unit 3.2b), and this propagates along joint and defect sets. The composition is predominantly quartz crystals, with subordinate feldspars, mica, limonite, and mafic minerals.

**Unit 3.1 Hornfels**

**Unit 3.2 Granite**

**3.2b Weathered Granite**

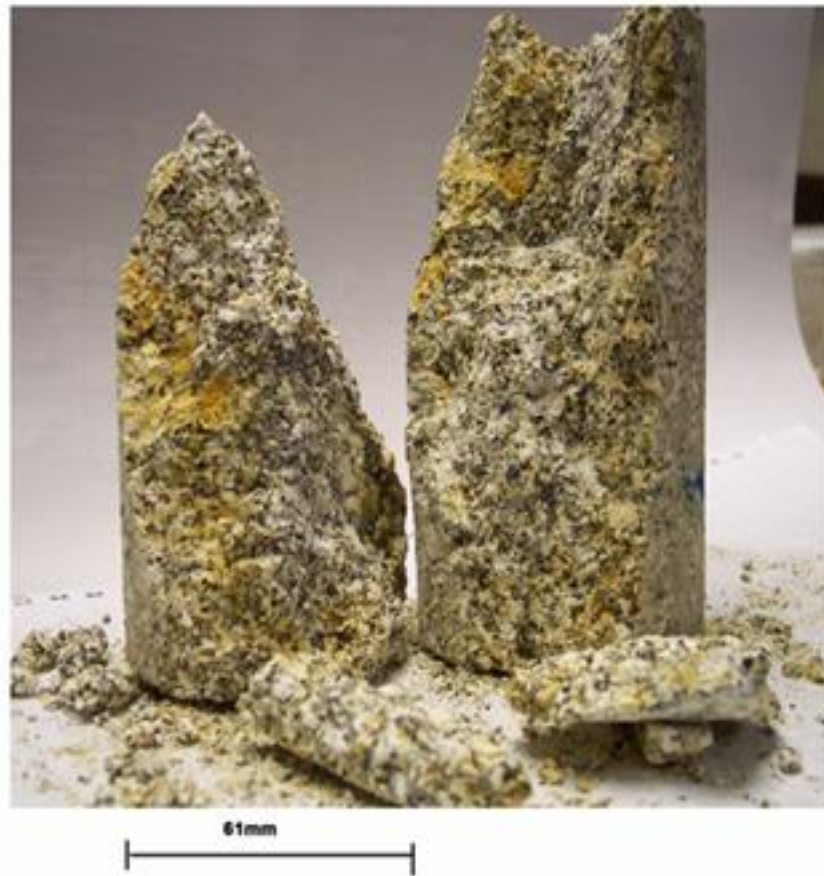
Figure 2.8. Weathered Berlins UCS core displaying cataclastic failure.

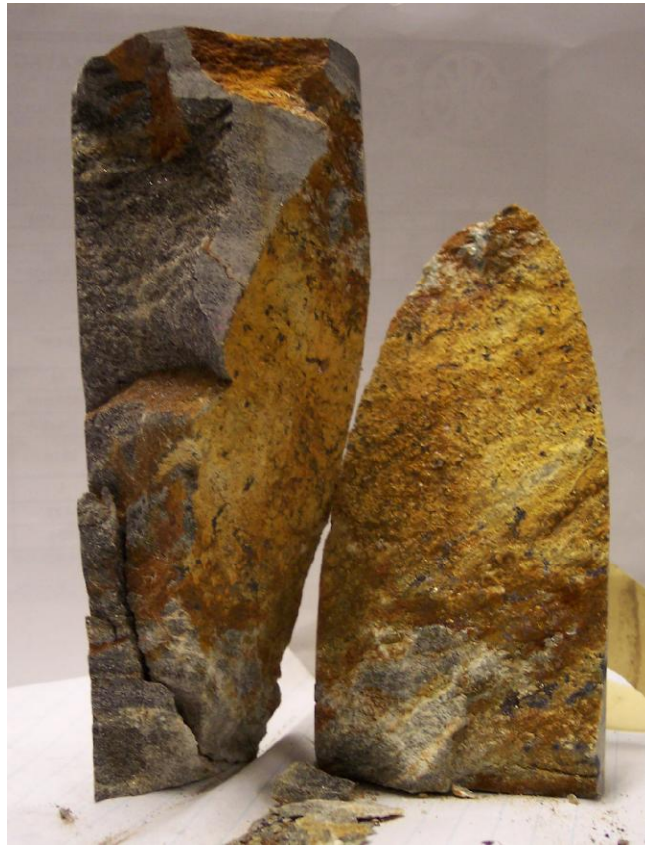
Figure 3.18 Sampled Greenland Group Exhibiting Iron Staining on Joint Surface
